TM 4967:70-616

DATE 24 February 1970

TECHNICAL MEMORANDUM

TITLE: Operation and Post-Test Inspection of the SNAP-8
Pre-Prototype Boiler P/N CF 751840, S/N 2

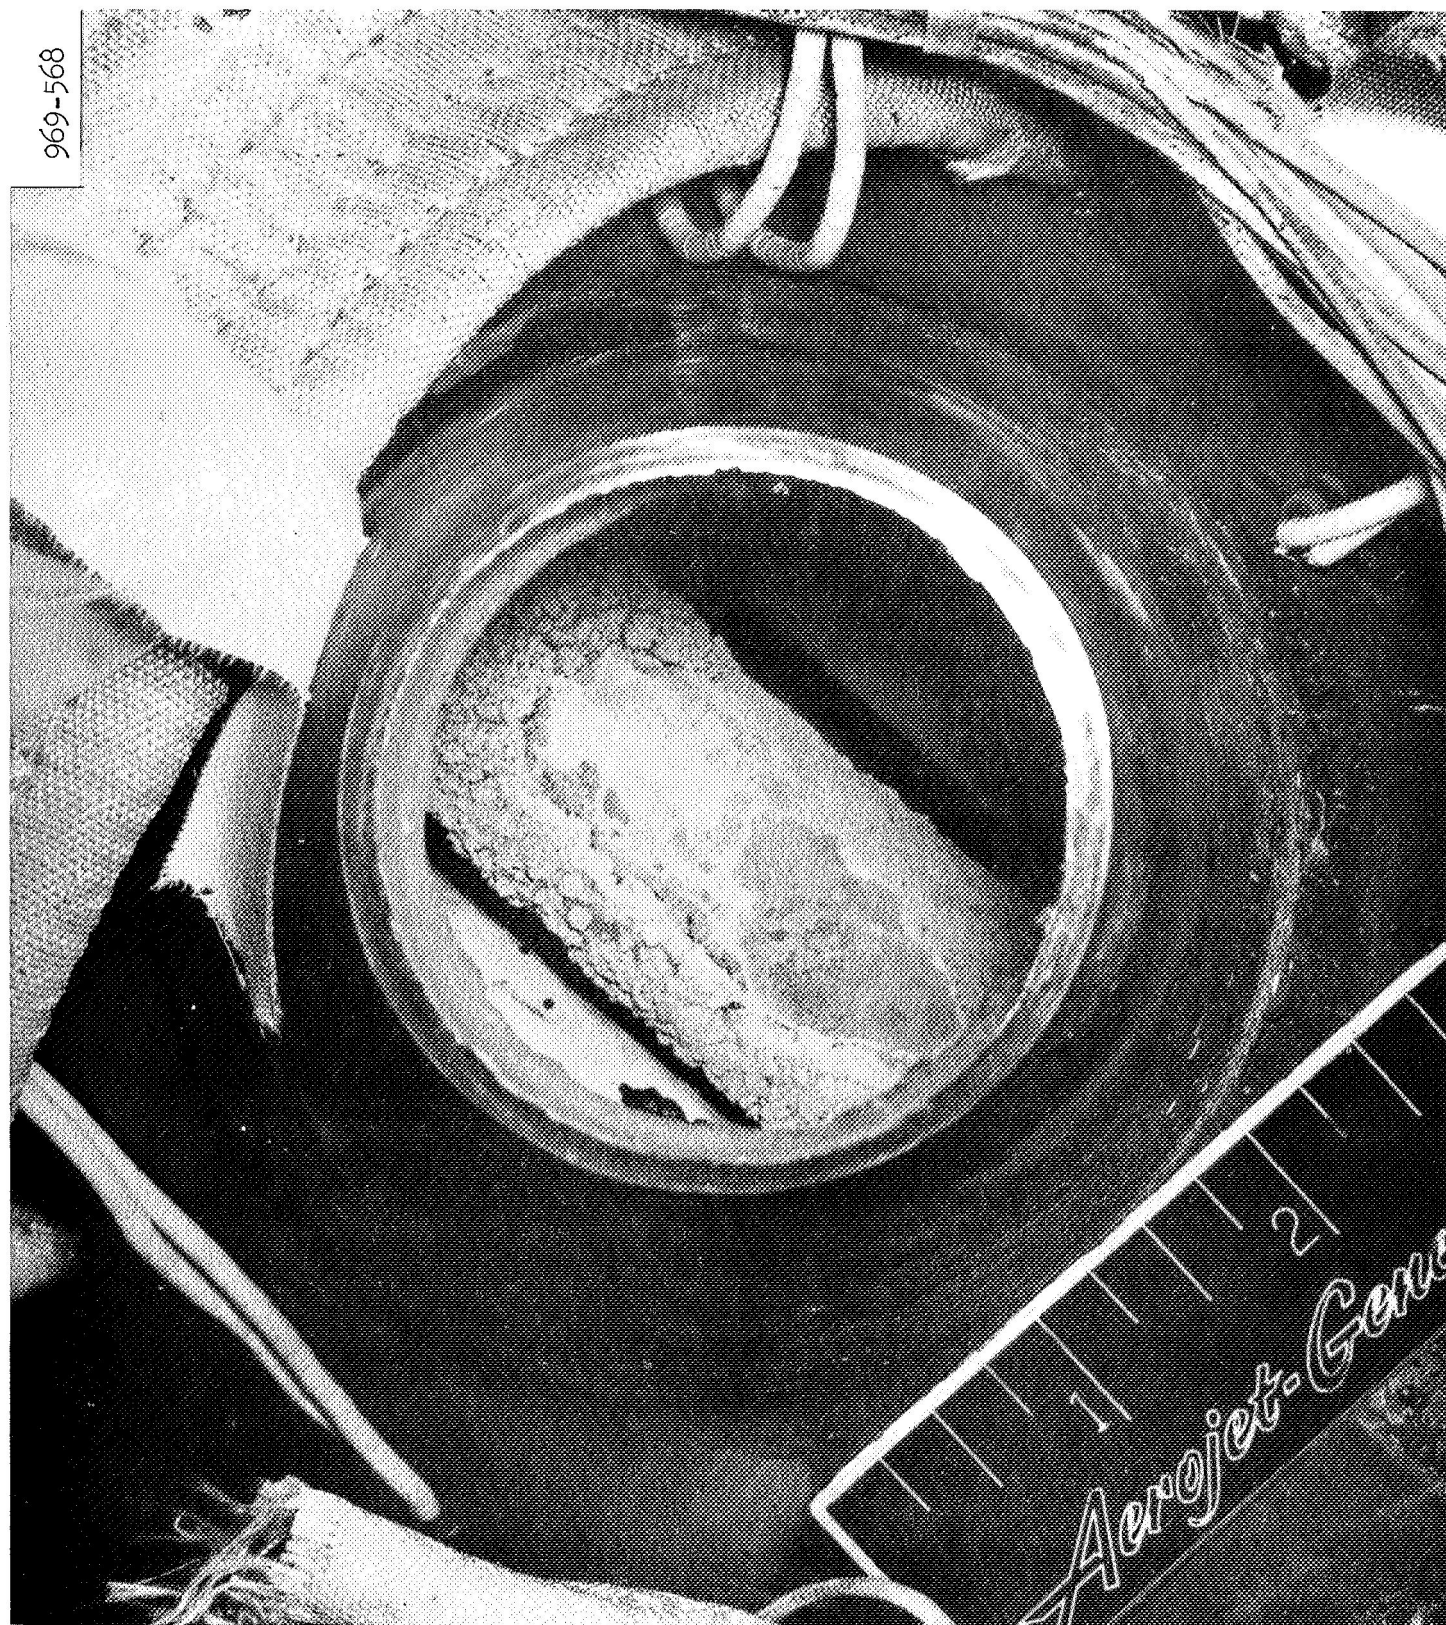
Figure 11 - The encrustation of the bottom static NaK tube as viewed through the primary NaK outlet was found to be NaK oxides with very little mass transfer deposit. This picture was taken after removal of the boiler from PCS-1 and prior to cleaning and disassembly.

VIEW OF STATIC NAK CONTAINMENT TUBE TAKEN THROUGH
NAK OUTLET PORT OF BOILER P/N CF751840, S/N 2
B/U 9/2 TESTED IN PCS-1 FOR 7386 HOURS, 29 SEPTEMBER 1969

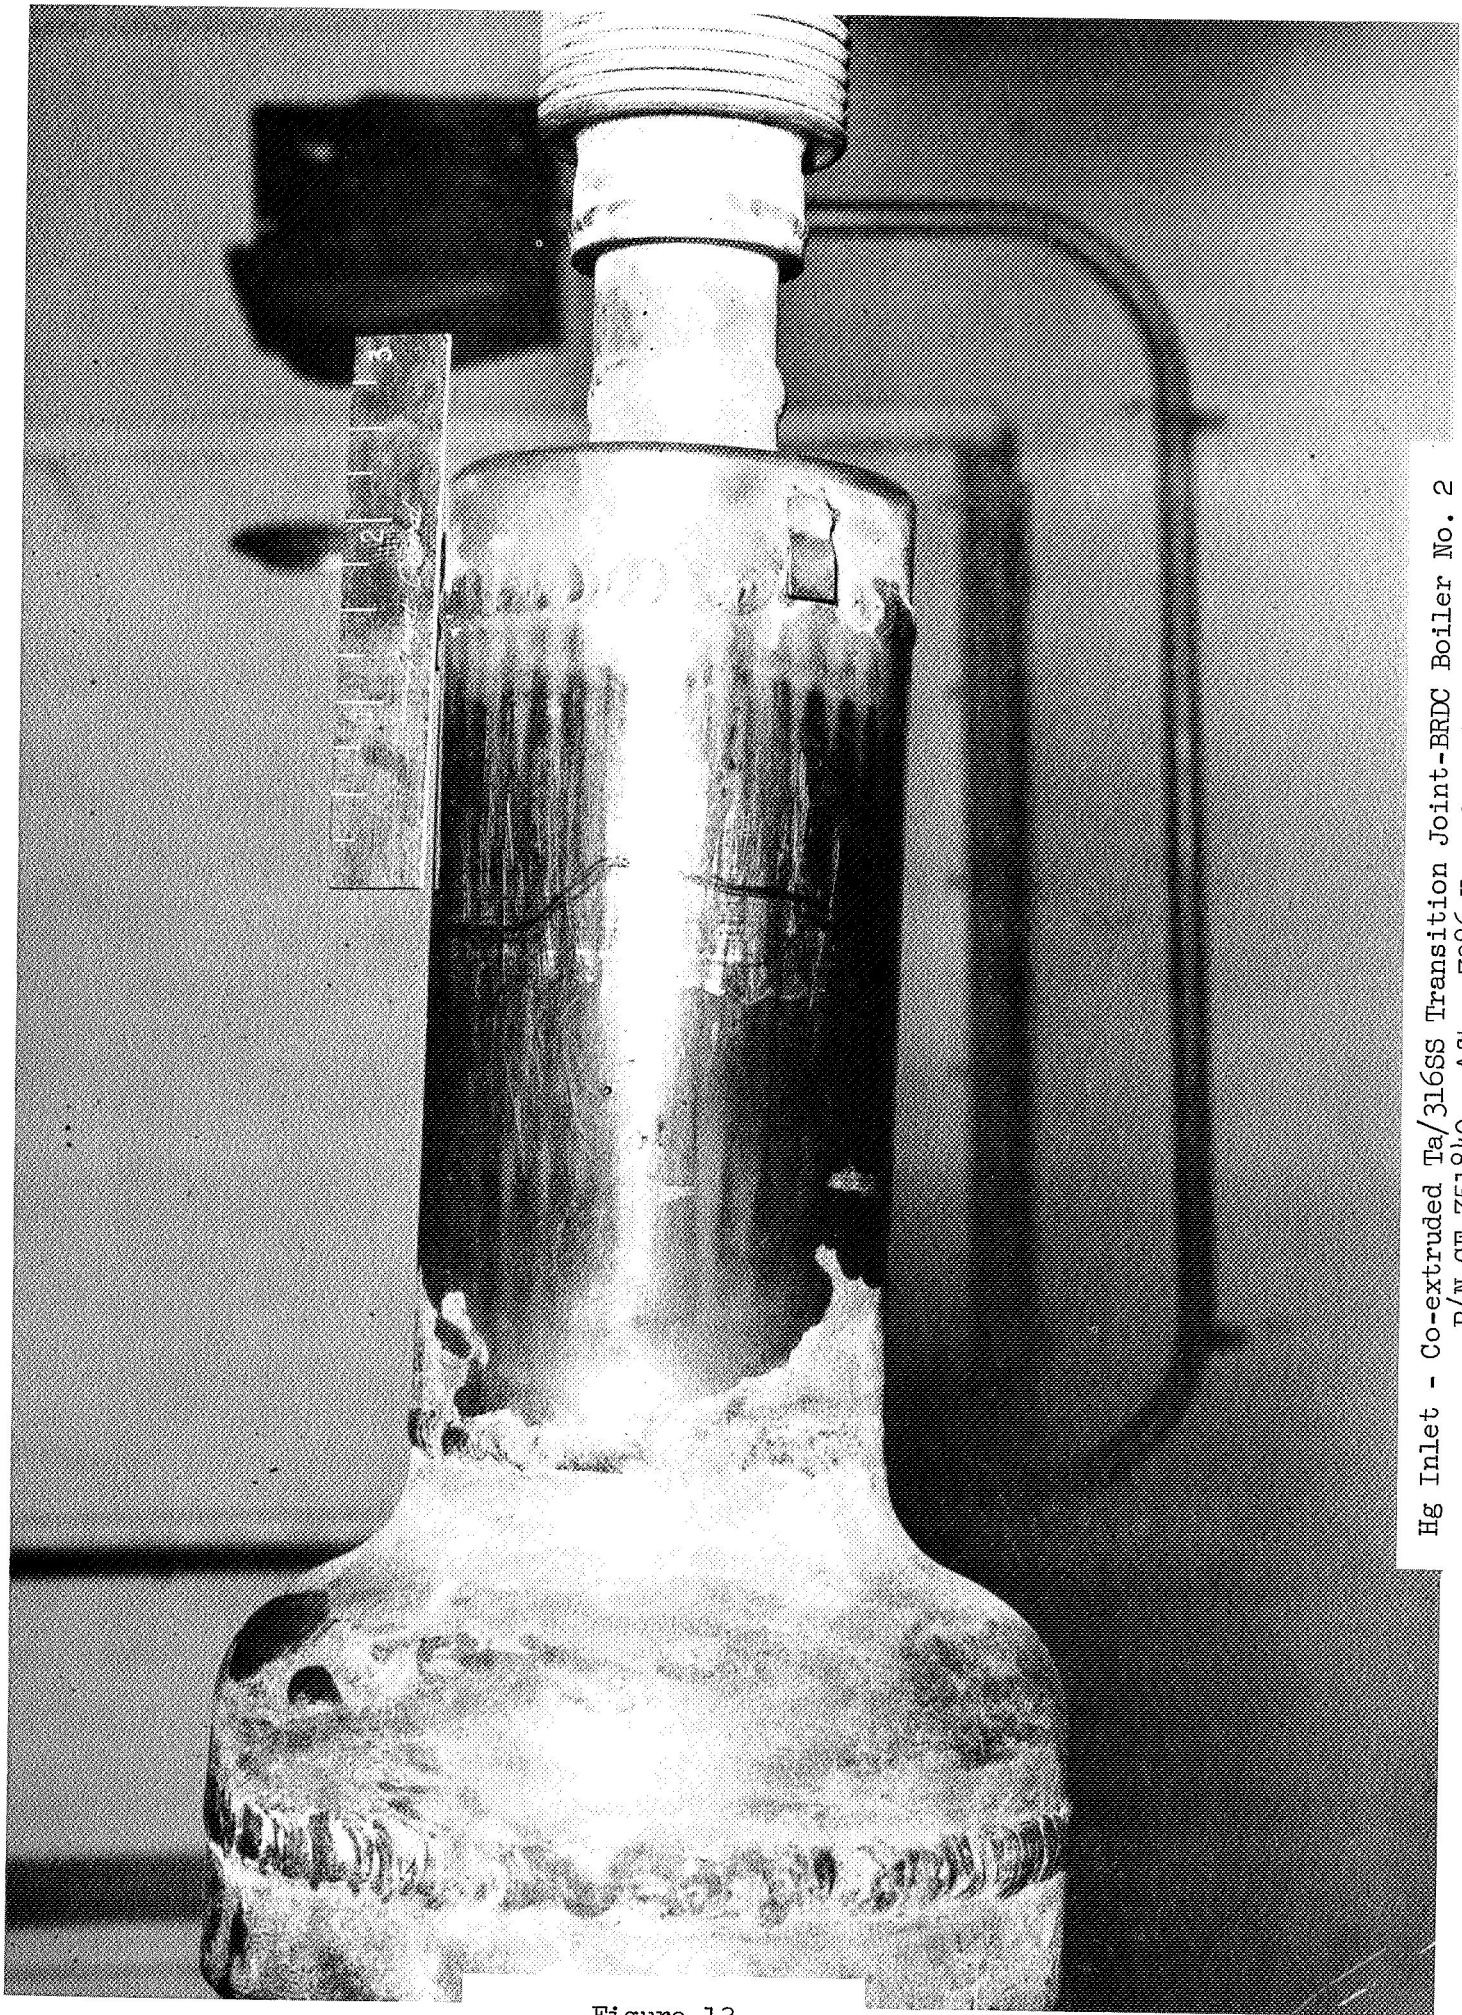
Figure 13 - The zirconium foil was removed from the mercury inlet to examine the tandem tantalum-to-316SS transition joint. This joint was ultrasonically inspected for debonding. The black wavy circumferential line shows the extent of the debonding which encompassed approximately one-half the circumference. The highlighted wavy circumferential line to the left of the black line is the runout of the stainless steel over the tantalum. It was estimated that approximately one-half of the joint is debonded at its worst. Dye-check of the area and the dome showed no cracking of the dome or welds but some indications were noted at the tantalum-to-stainless steel interface. Dye-check revealed no cracking in the bellows.

Hg Inlet - Co-extruded Ta/316SS Transition Joint-BRDC Boiler No. 2
P/N CF 751840 - After 7386 Hrs. Operation

1. The tandem transition joint at the mercury inlet would have to be redesigned or the co-extrusion process would have to be more closely controlled to ensure a better tantalum-to-stainless steel bond. The short life of this type of joint was borne out by thermal cycling in the Metallurgical Laboratory. If increased life is unattainable, the joint should be replaced by an axially co-extruded bimetal joint of sufficient length or by a rigorously controlled brazed joint similar to the mercury outlet joint.

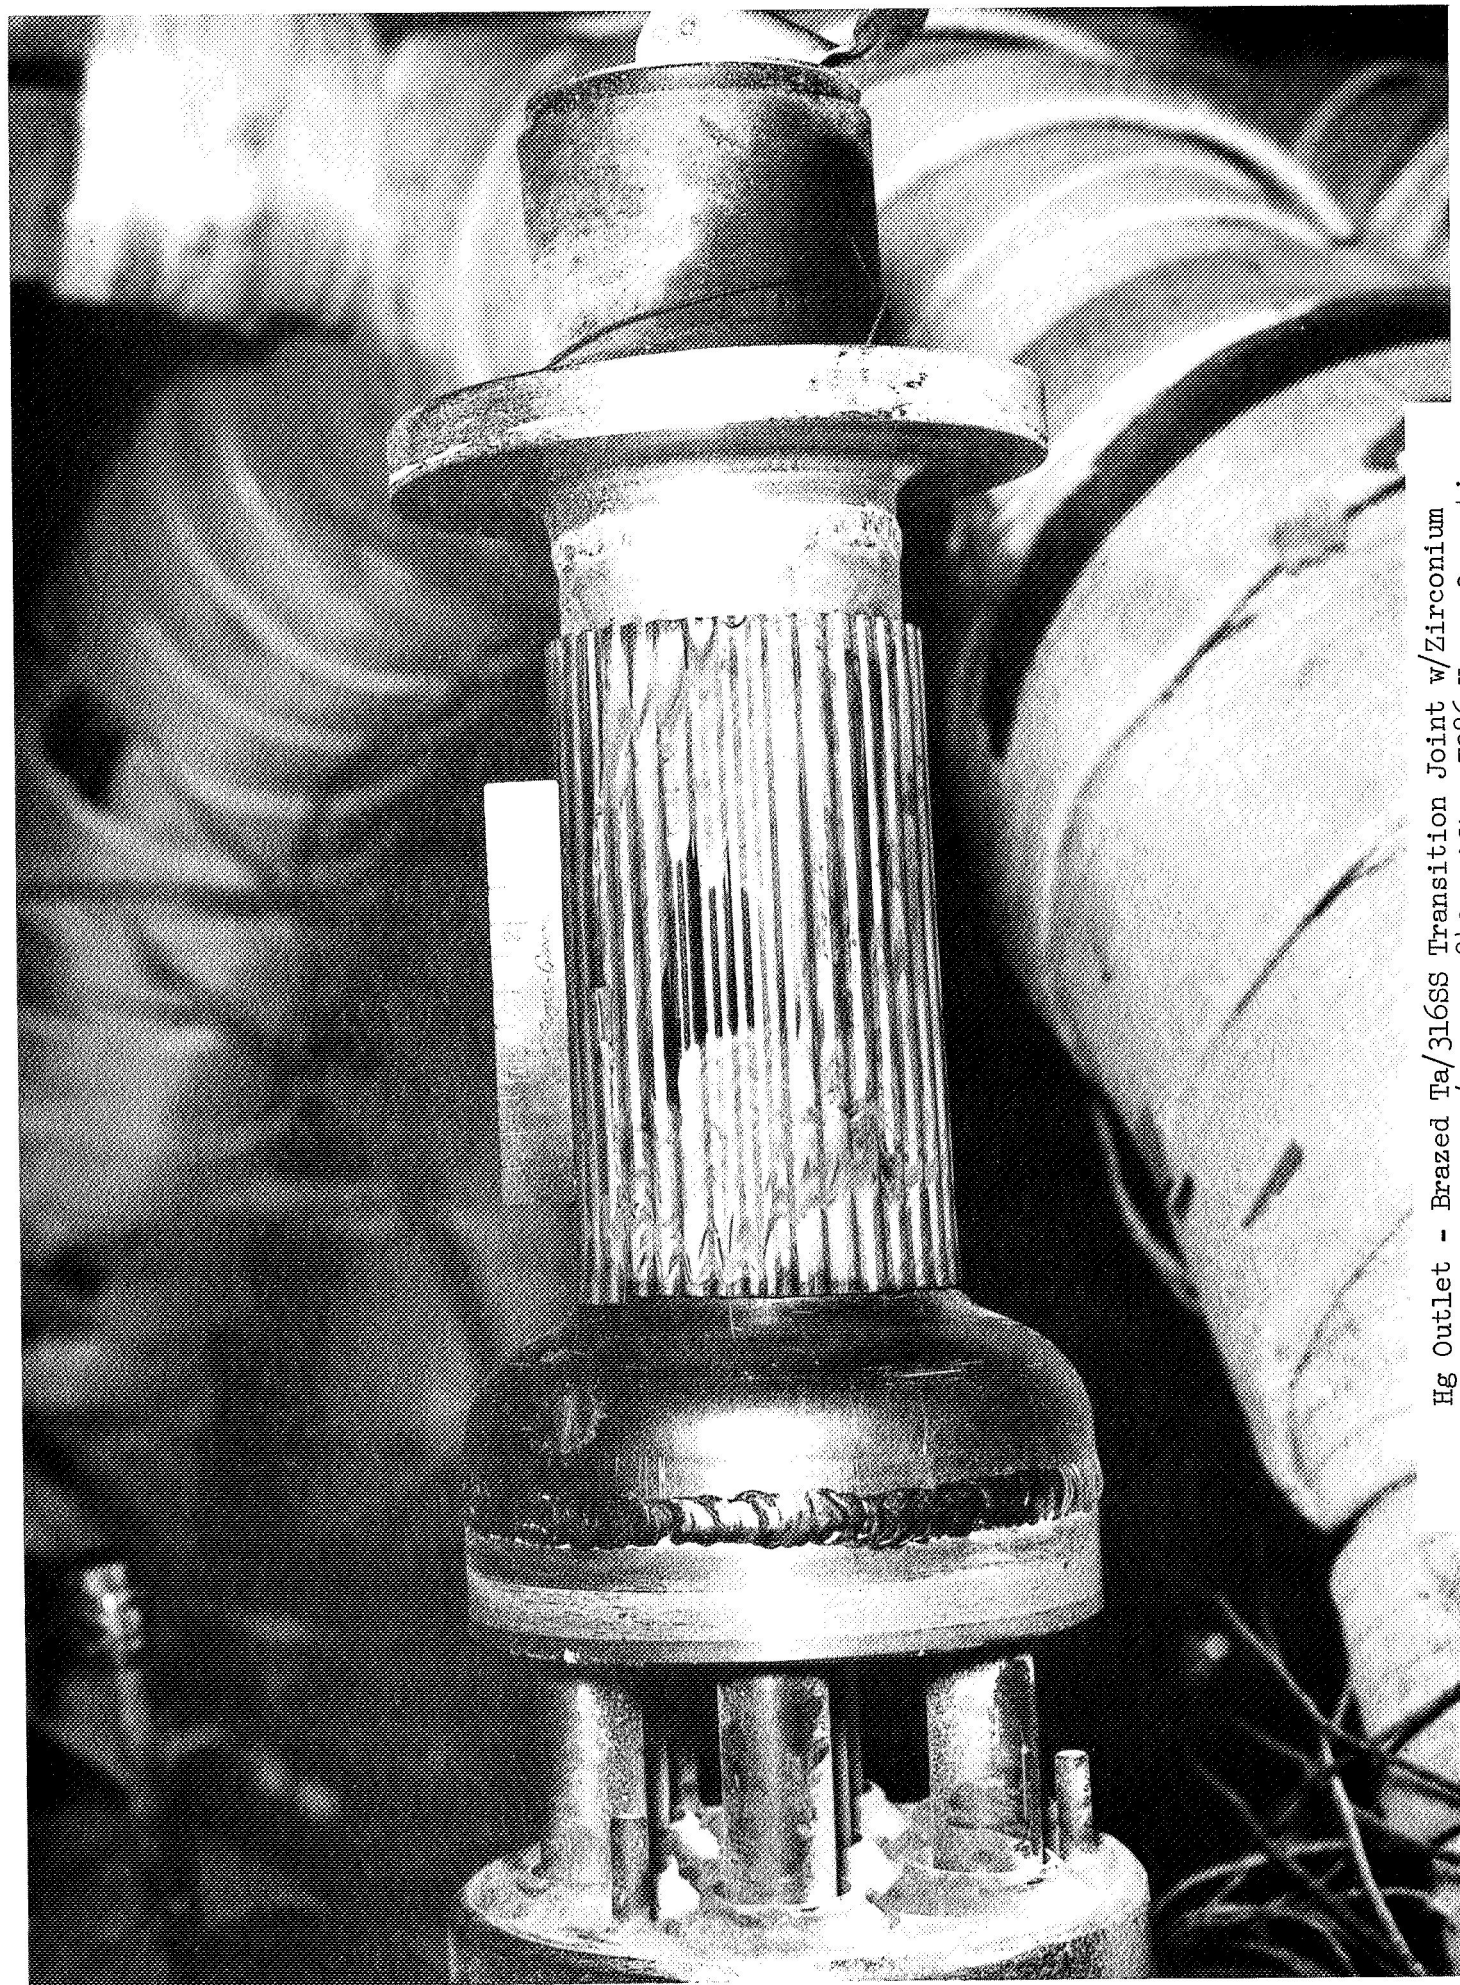
Figure 14 - The mercury outlet tantalum tubes, tantalum dome, zirconium corrugated foil and stainless steel header are shown. The indentation that can be seen on the tantalum dome was present when the boiler was first assembled. The zirconium foil is in a much better condition here than that shown at the mercury inlet.

Hg Outlet - Brazed Ta/316SS Transition Joint w/Zirconium
Foil-BRDC Boiler No. 2, P/N CF 751840 - After 7386 Hours Operation

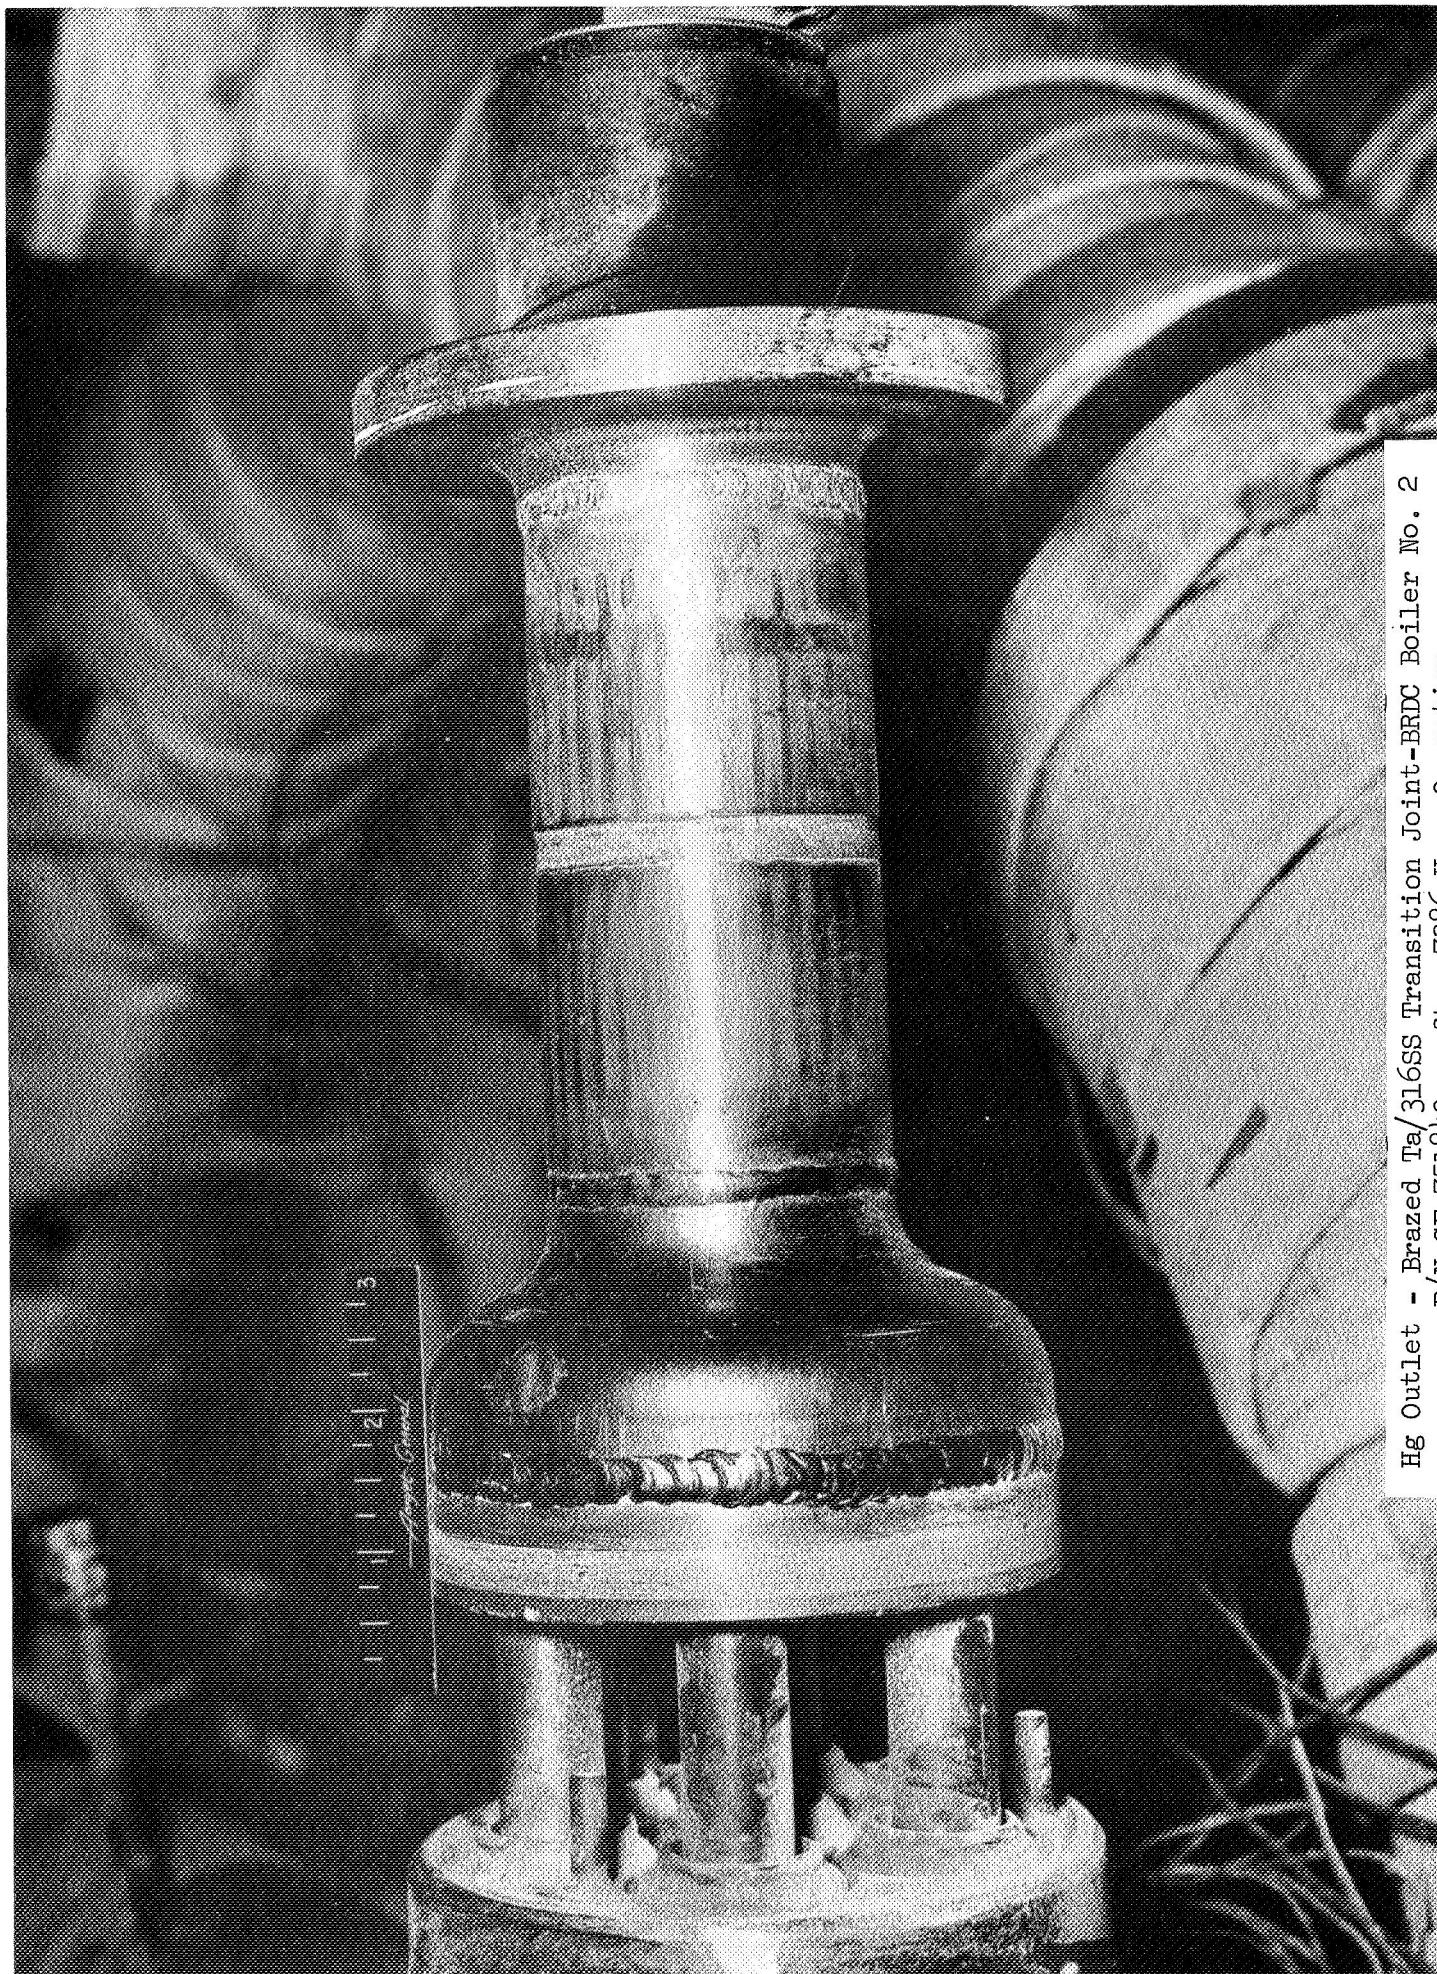
Figure 15 - The zirconium foil was removed from the mercury outlet to examine the brazed tantalum-to-stainless steel transition joint. Dye-check of all parts indicated no cracking in any of the parts.

Hg Outlet - Brazed Ta/316SS Transition Joint-BRDC Boiler No. 2
P/N CF 751840 - after 7386 Hrs. Operation

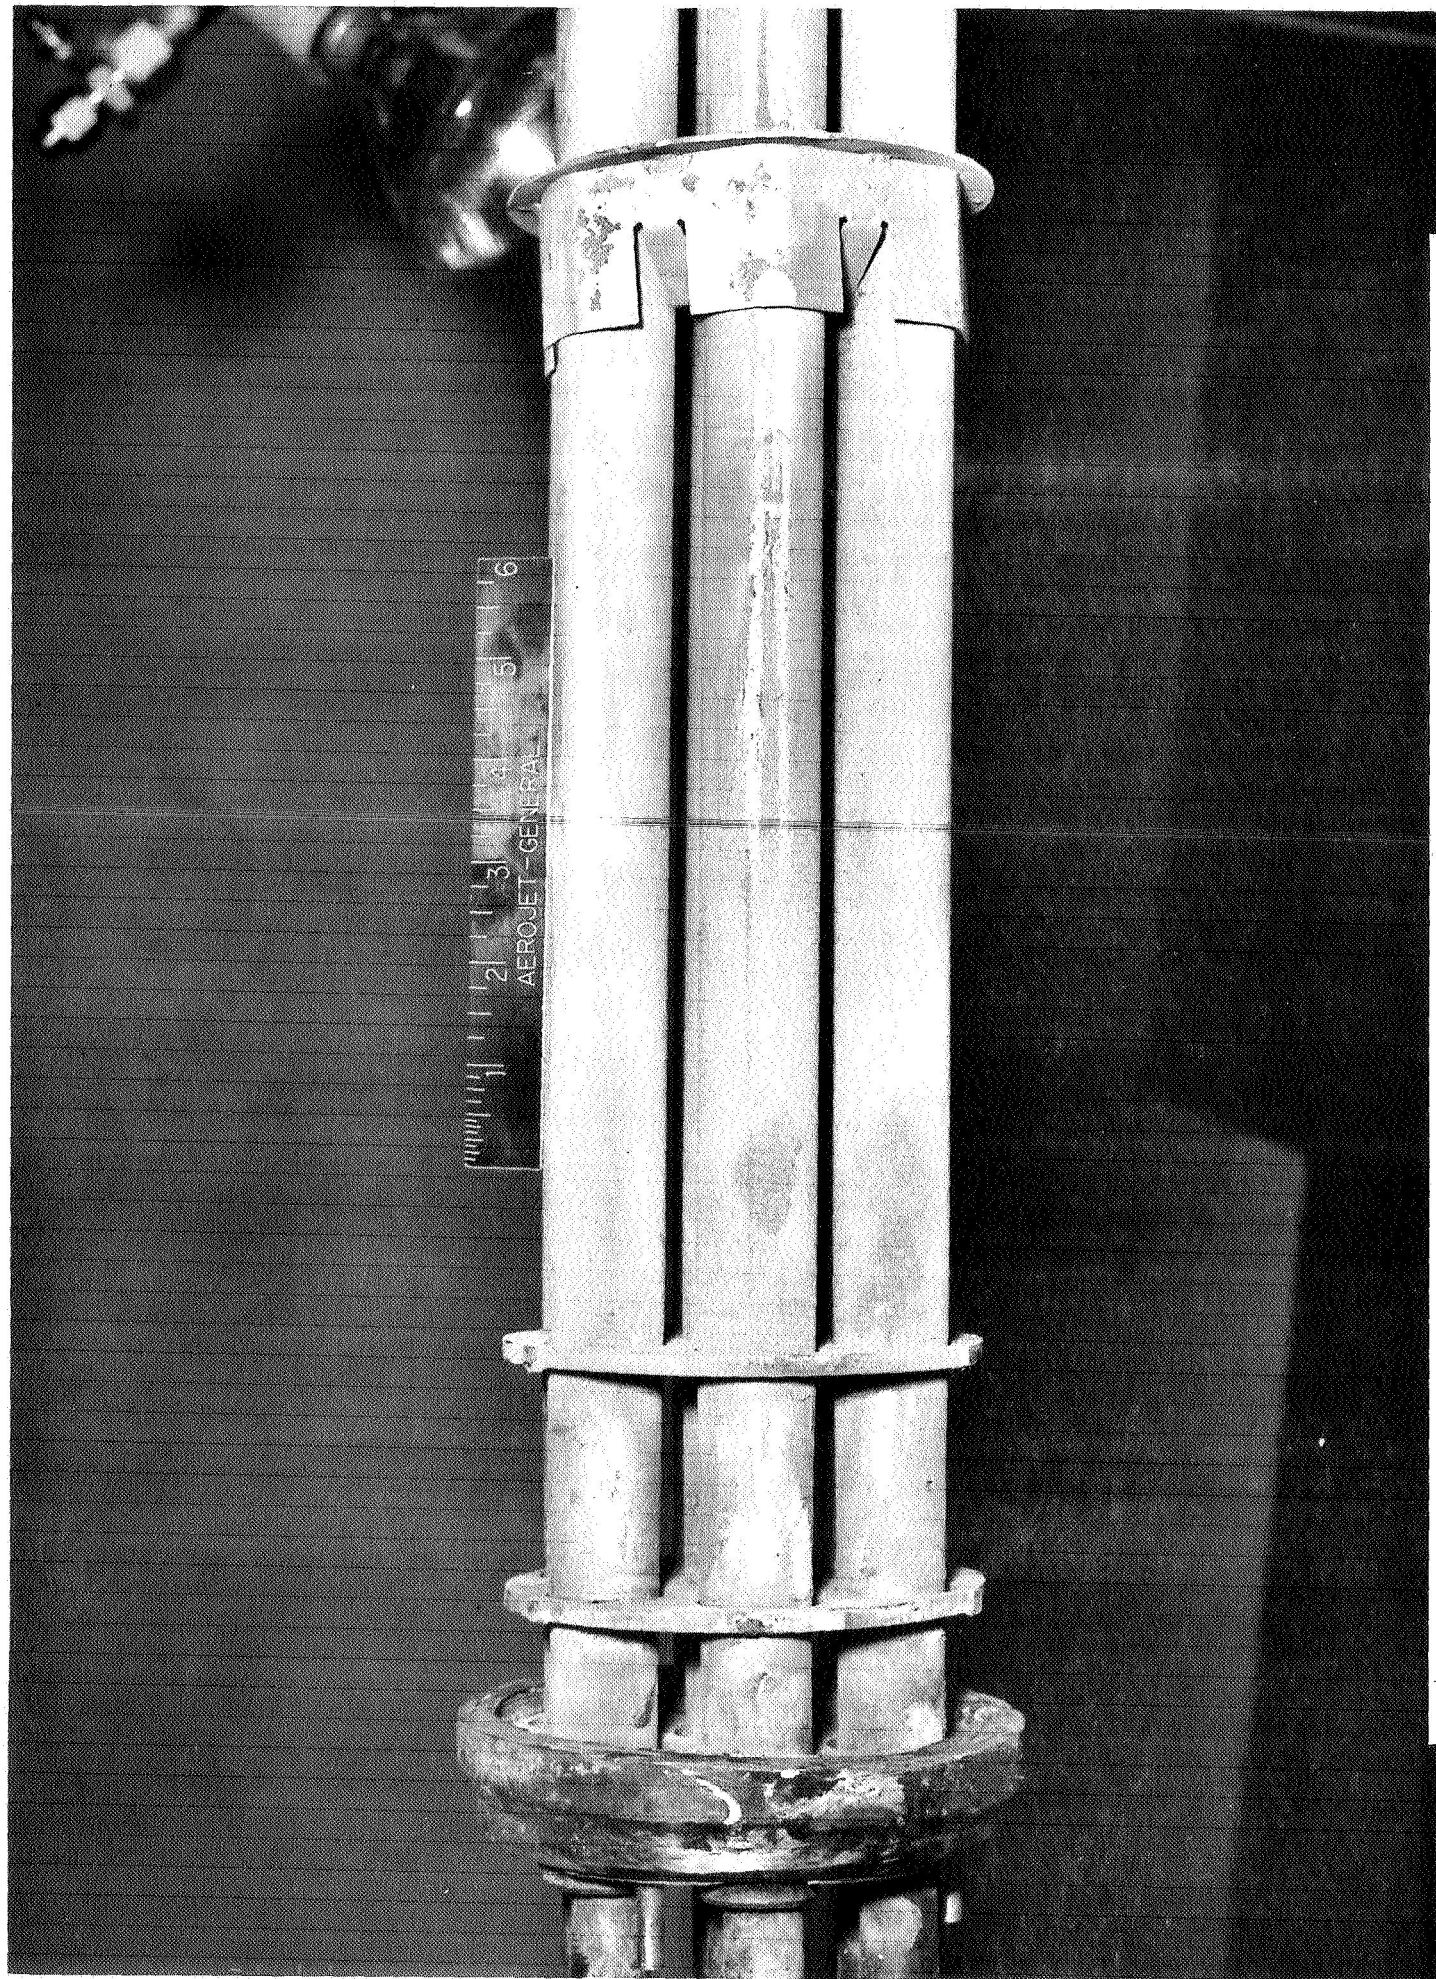
Figure 16 - This photo shows the 321SS static NaK tube bundle, the 316SS header, the two baffles and the tube bundle support. The center static NaK tube, as shown, cracked just to the left of the right baffle.

BRDC Boiler No. 2, Tube Bundle Section at NaK Outlet. Operating Time 4061 Hours to Failure

3. It appears that the method of baffling the primary NaK flow at its exit has to be carefully analyzed to preclude excessive axial and circumferential thermal gradients versus axial and circumferential lengths. The cracks in the static NaK tube at the baffle indicate that thermal stress was the predominant failure mode.

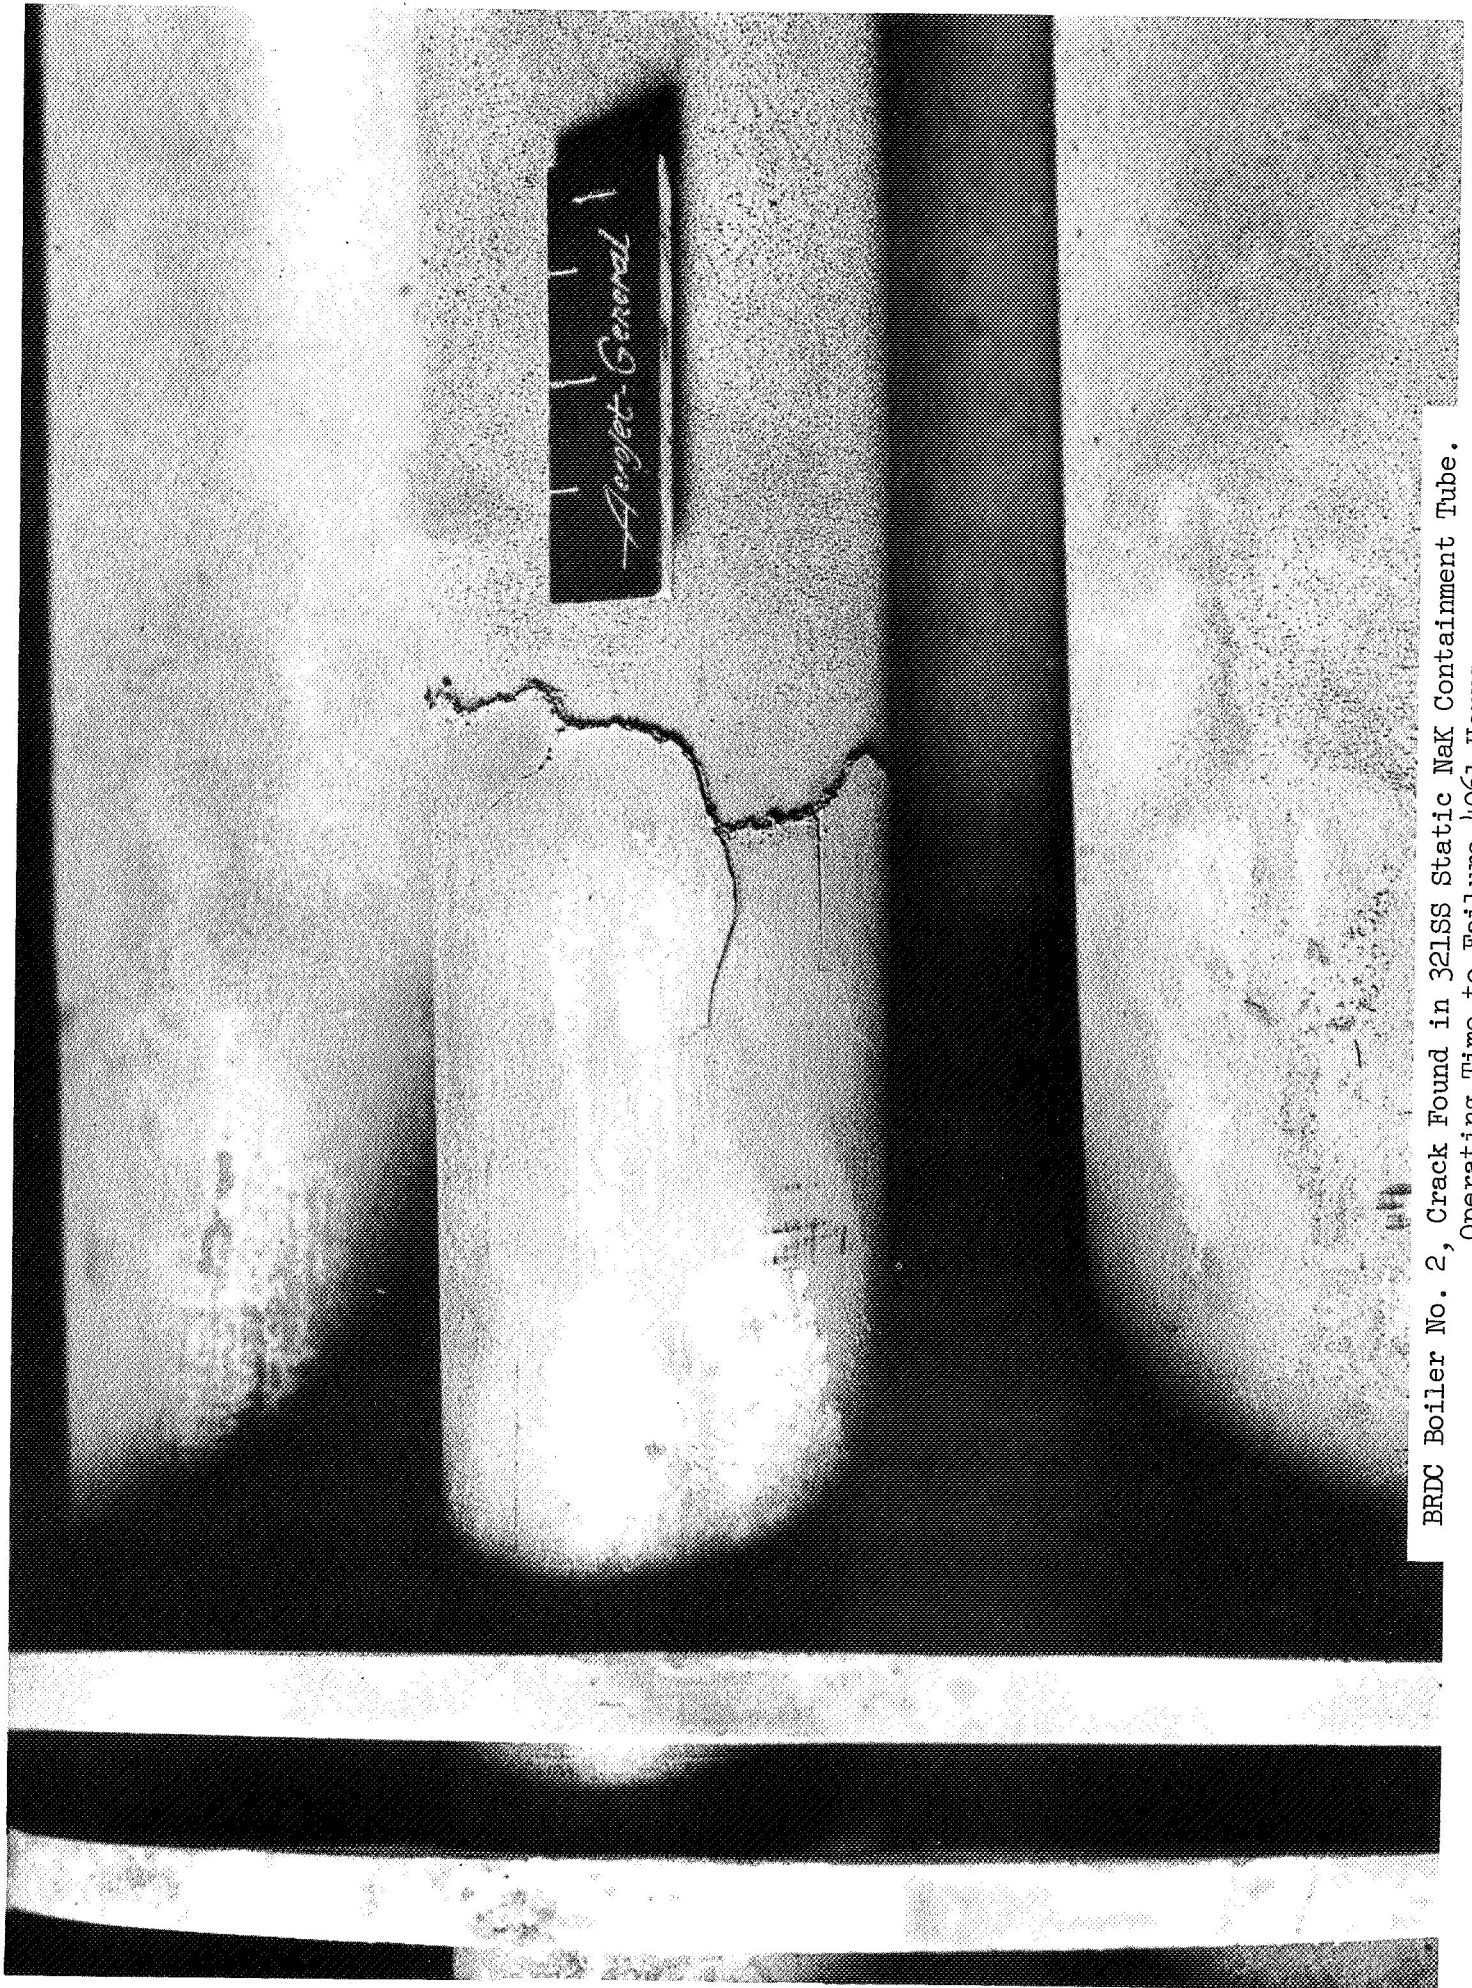
Figure 17 - This photo shows the cracks in the static NaK tube with the baffle moved to the left. This section of the tube was removed for metallurgical analysis by the Materials Group (see Appendix B). The stippled area to the right of the cracks was found to be mass transfer deposits. When the cracked section of the tube was removed it was noted that the tantalum tube underneath (shown in Figure 18) was eroded or "washed out" to a depth of .010-.020". This anomaly occurred during boiler operation at temperature, as borne out by a dimensional stackup of the parts. In the cold condition, the tantalum tubing eroded area was 0.537" to the left of the crack as shown in this photo.

BRDC Boiler No. 2, Crack Found in 321SS Static NaK Containment Tube.
Operating Time to Failure 4061 Hours

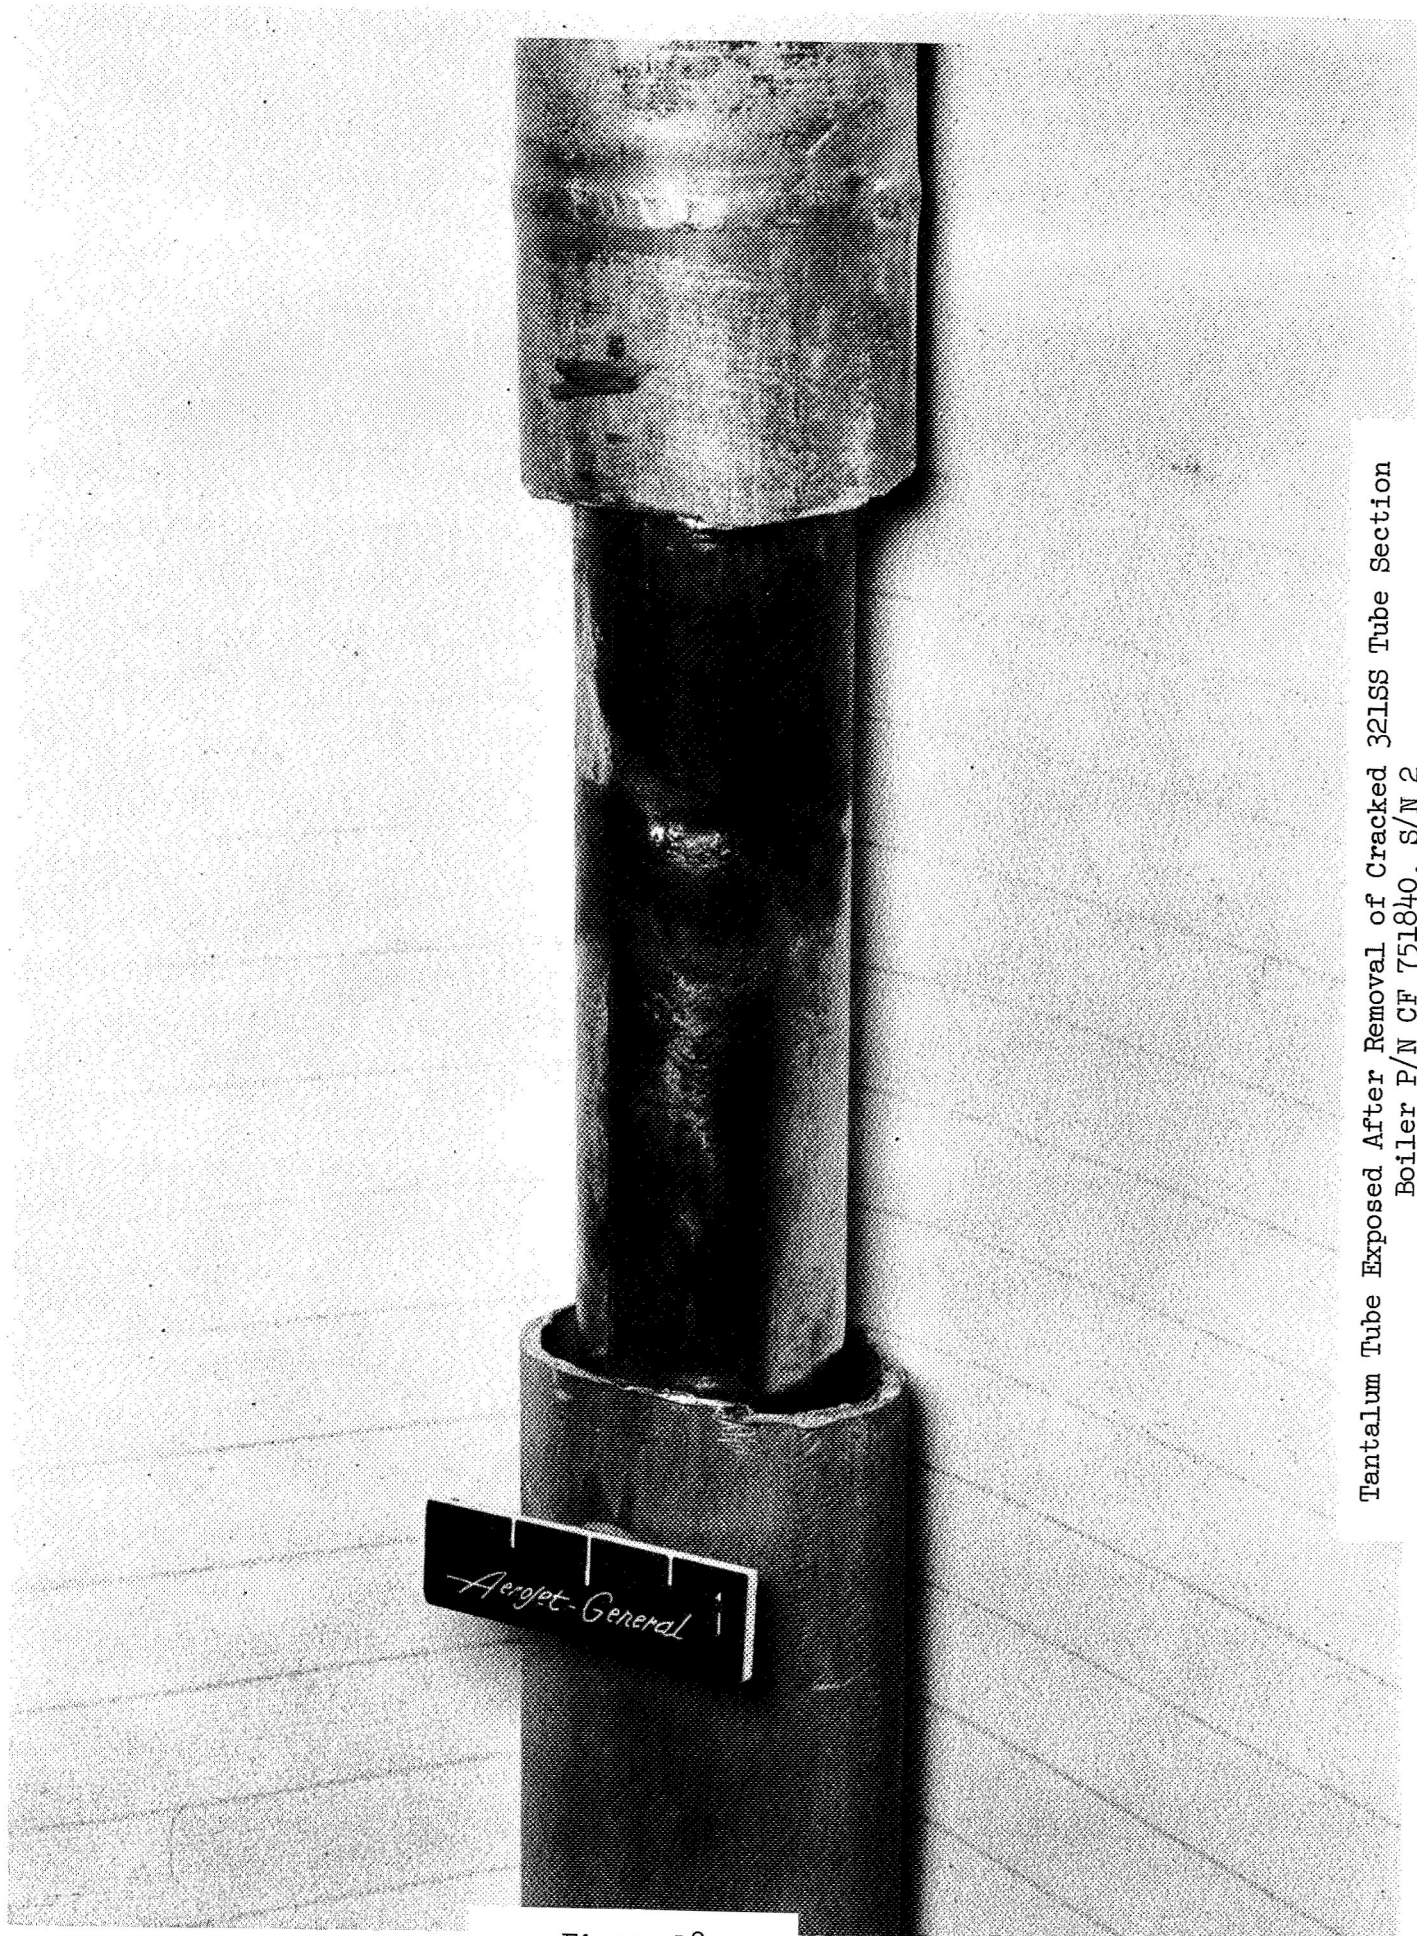
Figure 18

It was observed that severe localized thinning had taken place on the O.D. surface of the tantalum tube directly beneath the 321SS tube crack. From a dimensional stackup of the boiler parts, it was found that the "washed out" area of the tantalum tube would be directly beneath the crack when the boiler was at full operating condition. In the cold condition, it was 0.537 inch upstream of the crack (toward Hg inlet). The maximum depth of the "wash-out" was .0185 inch or 46% of the .040 inch thick wall tantalum tubing. Examination of the surface showed a smooth, blended surface with no difference in hardness and structure from the unthinned surface and no evidence of oxidation.

Tantalum Tube Exposed After Removal of Cracked 321SS Tube Section
Boiler P/N CF 751840, S/N 2

3. PCS-1 operational modifications and improvements should be made to eliminate organic contamination of the Hg loop.
4. The conditions which produced the Ta tube wall thinning under the crack in the 321SS static NaK containment tube should be simulated to determine if this is a potential failure mode, and to establish the mechanism causing the thinning.
